# Ambient vibration testing and operational modal analysis of a historic tower

M. Diaferio, D. Foti, and N. I. Giannoccaro

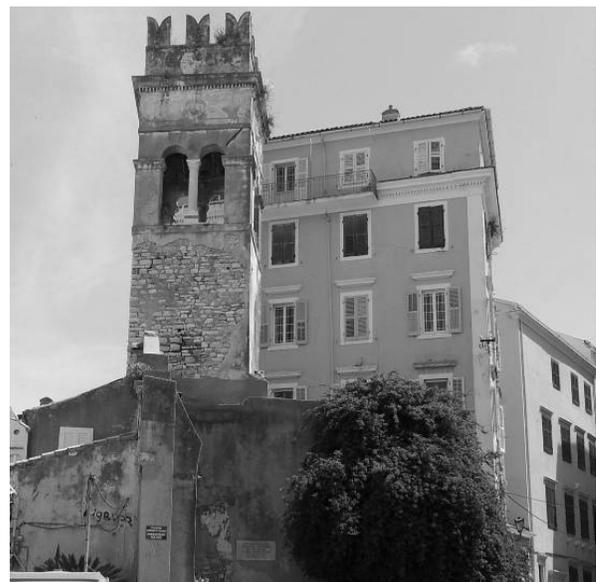
Fig. 1. Announziata bell tower.

applications. Other approaches makes use of the experimental evaluation of the modal parameters of the structure. The modal parameters may be compared with those of the model and the unknown materials and geometrical parameters may be estimated for obtaining an accurate FE model. These techniques have the advantage of providing information on the overall structure with a reasonable experimental effort [10-32]. In this paper, the case of study is the bell tower of Announziata, a masonry tower (Fig. 1), which shows a high damaged scenario. The bell tower of the church is located in the town of Corfù, Greece. The church was built in 1394 and it was one part of a Roman monastery, nowadays the only existing one. The interior of the church [1] contained the tombs of generals who died in the sea battle of Naupactus (1571). The church of Announziata was bombed during the second world war and it suffered from cracking; then it collapsed in March 1952 when long term phenomena and earthquakes contributed to increase the damage. So, from 1952 only the campanile of the medieval monastery has survived to the present day with heavy cracking. It is possible to observe deep vertical and diagonal cracking, deterioration of mortar on the stone walls and development of creepers in the masonry. The bell tower is a stone tower with an almost square plan section. A double arch (Fig. 1) supported by a stone column in the center is present at each of the four façades.

The structure of the tower is made with masonry walls and the three floor systems made by solid bricks are supported by vaults. At the top of the tower there is the bell cell with four bells. The current state of the tower may be defined critical, with many damages and cracking.

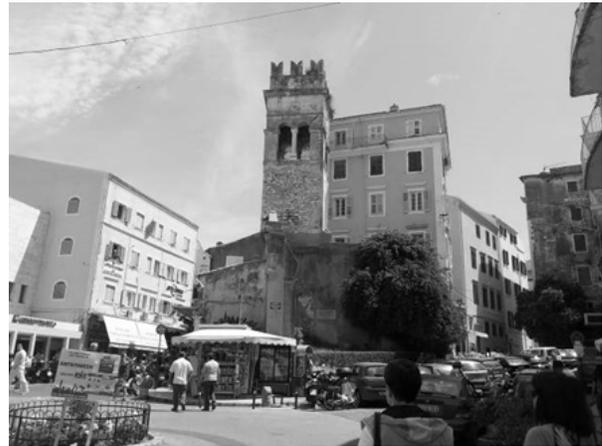
Fig. 3. Position of the Annunziata bell tower.

The bell tower is positioned in the city center, in a crowded area especially during the day time. There is a main entrance road open to the car passage and a rotatory (Fig. 3) very close to the tower where cars and trucks can select the preferential way. The continuous passage of bikes, cars, motorcars and pedestrians has characterized all the environmental tests.
