# Cyclic in-plane testing for evaluation of shear capacity for ceramic block walls

Eva. Partene, Andrei. Bindean, Mihai. Fofiu, Valeriu. Stoian, Luminita. Fekete-Nagy

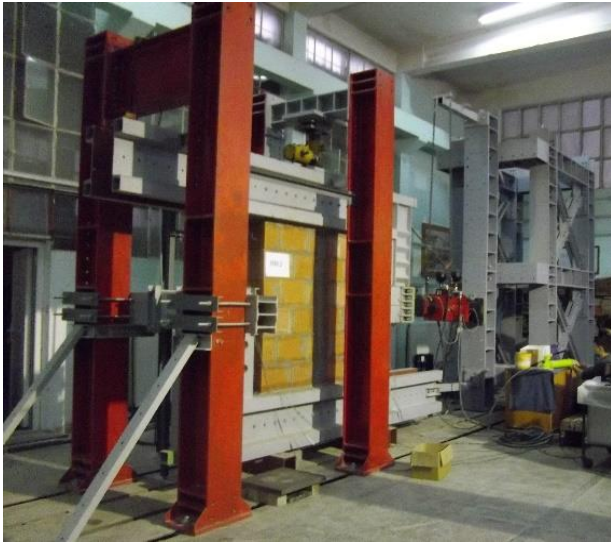
The test frame considered, is built of three main parts: a reaction frame for the horizontal load, a reaction frame for the vertical load and a sliding frame as seen in Fig. 1. The horizontal load was transferred through the sliding frame to the test units. A dynamic actuator was used to carry out displacement control tests.

Instrumentation consisted in 12 displacement traducers and 2 pressure traducers in order to determine the drift of the wall, the forces applied and to determine if there is any out of plane displacement, as seen in Fig. 1.

Fig. 1 Experimental stand and loading scheme

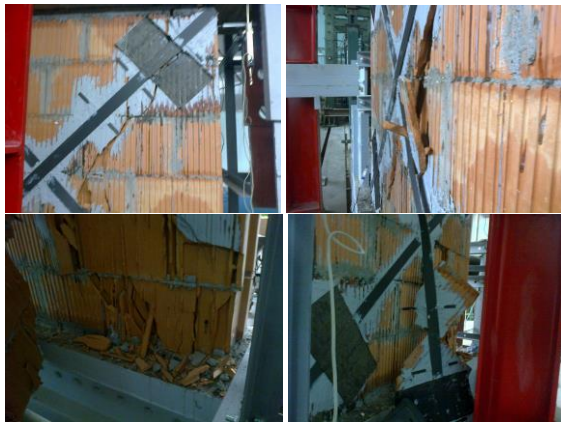
The first retrofitting solution, using FRP carbon plates, even though involves higher costs, had a very good result. The maximum load increased with 85%. The failure mode was very fragile, the disadvantage been the splitting of the carbon plates with the peeling of the ceramic blocks, as seen in Fig. 5.

Fig. 5 Failure mode for URM1-C (URM1-strengthened)

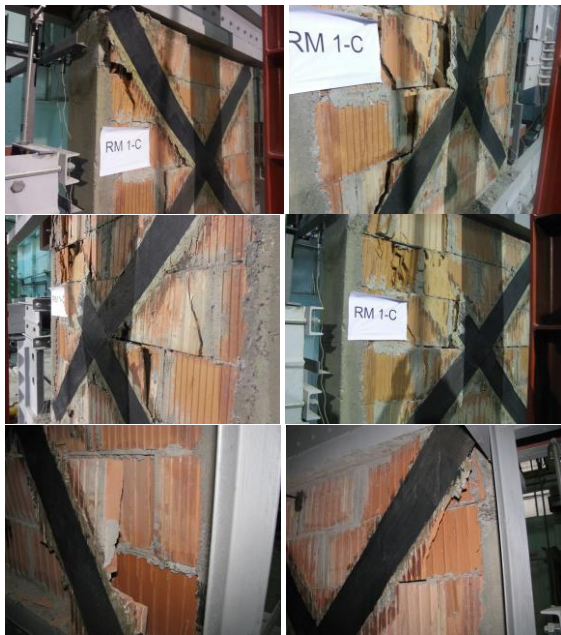
For the second masonry wall RM1, the retrofitting solution was with CFRP mesh. The surface was uniformed also a thixotropic epoxy resin and after drying, the mesh was applied using a glued resin. The results were not so spectacular, but the wall was able so support a horizontal maximum load similar

with the initial wall, which proves the efficiency of this type of retrofitting solution. The failure mode was also fragile, with the splitting of the CFRP mesh with the peeling of the ceramic block as seen in Fig. 6 [6].

Fig. 6 Failure mode for RM1-C (RM1-strengthened)
