Flash flood on July 21, 2014 in the Vratna Valley

P. Pekarova, V. Bacova Mitkova, P. Miklanek

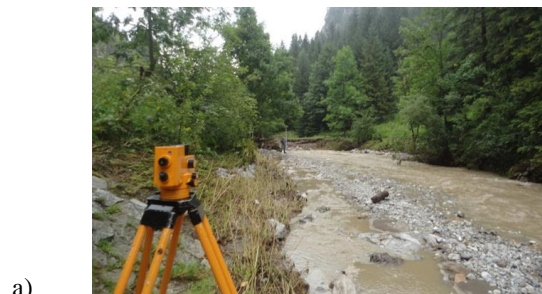
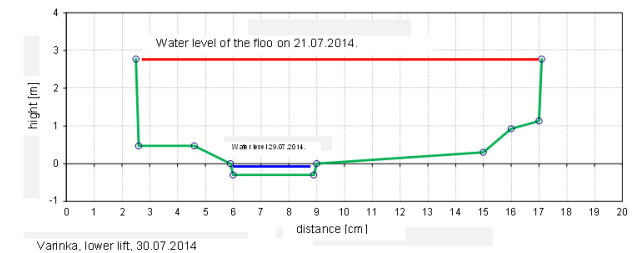
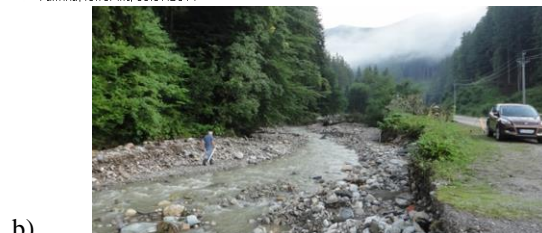
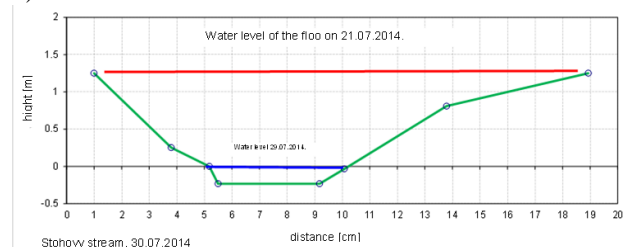
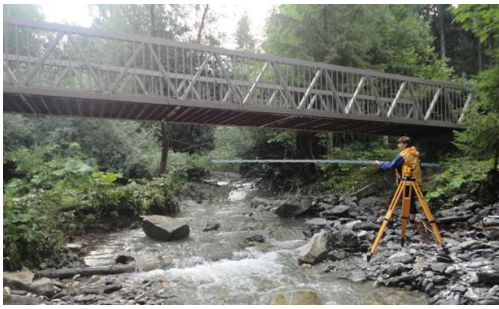
c)
Fig. 4. a-c. Fixation of the cross sections on Varinka and Stohov streams according to flood tracks of the flood on July 21, 2014.

- a) on the Varinka stream in valley Tiesnavy (Fig. 4a);
- b) on the Vrinka stream at lower lift station (Fig. 4b);
- c) on the Stohovy stream near the mountain rescue cottage in Stefanova (Fig. 4c).

According to our measurements after the flash flood on Varinka in the Vratna Valley the peak discharge reached at least value of 56 m³s⁻¹ and specific flow reached value of 2 m³ s⁻¹ km⁻² (on the Varinka stream in valley Tiesnavy, catchment area is 28.05 km²).

Peak discharge reached value of 57 m³ s⁻¹ and specific yield reached value of 4.4 m³ s⁻¹ km⁻² (with respect to smaller basin area) on the Varinka stream at lower lift station. Peak discharge reached value of 6.7 m³ s⁻¹ on the Stohovy stream.

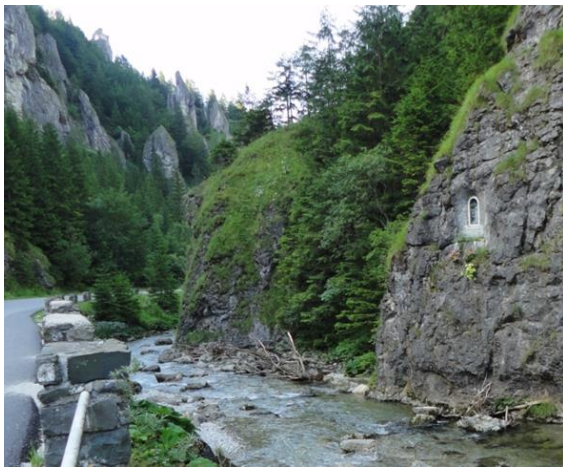
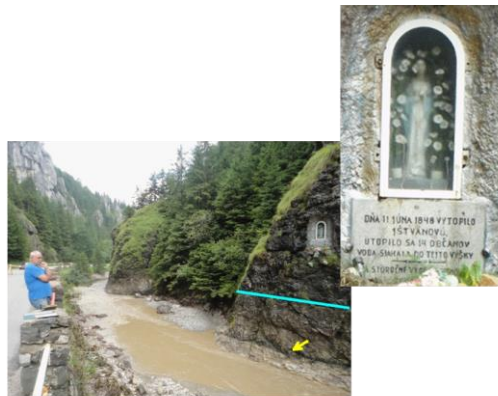
Photo 1. a) Flood mark situation in 2012, b) Detail of flood mark with indicated water level in 1848 and flood water level in 2014 fixed after the flood with the stream bed nicked by 60 cm approximately (white rock above the water). (Photos by Pekarova, 13.07. 2012 and 30.07. 2014).

The lower photo (Photo 1b) shows water level in 2014. Comparison of the photo 1b with photo 1a (flood in 2012) shows 60 cm brighter layer of rock. Flow of the Varinka stream in this narrow profile took away almost all of the bottom sediments and revealed the bedrock.

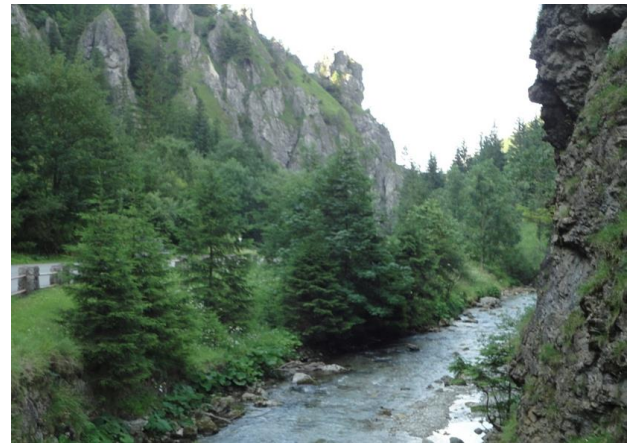
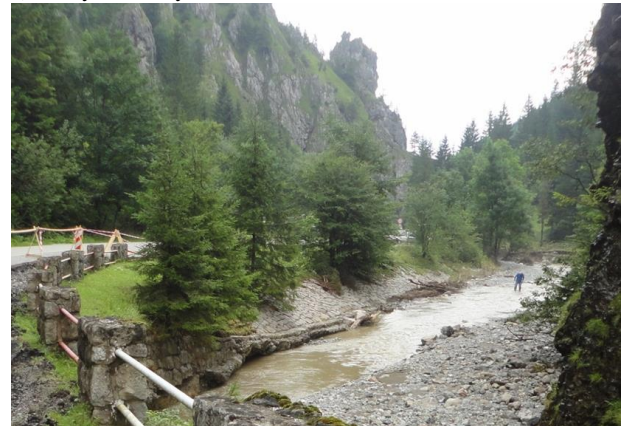
Photo 2. a) - b) Original status of the stream channel in 2012 and the stream channel raked out by the flood on July 21, 2014. (Photos by Pekarova 2012 and 2014).

Similarly, Photo 2 a)-b) shows riverbed of the Varinka stream in Tiesnavy with two years delay. Photo 3 shows catastrophic mud flows in the Malá Fatra Mountains due to extreme rainfalls on July 21, 2014.

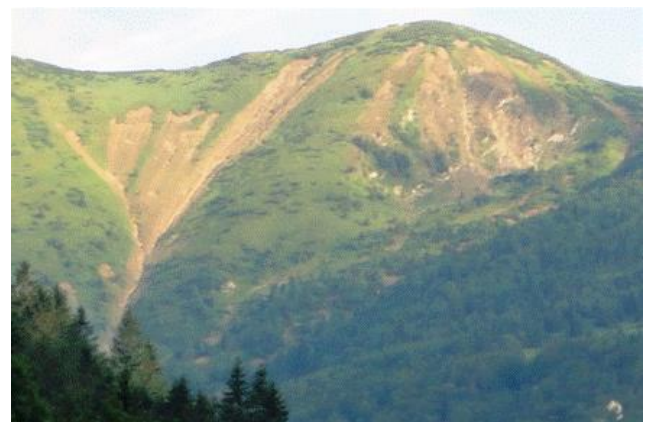
Photo 3. Catastrophic mud flows in the Malá Fatra Mountains due to extreme rainfalls on on July 21, 2014 (Photo by Miklanek, 2014).
